Rover Delivery

2017-2018 NASA University Student Launch Initiative Post-Launch Assessment Review

Charger Rocket Works

April 27th, 2018

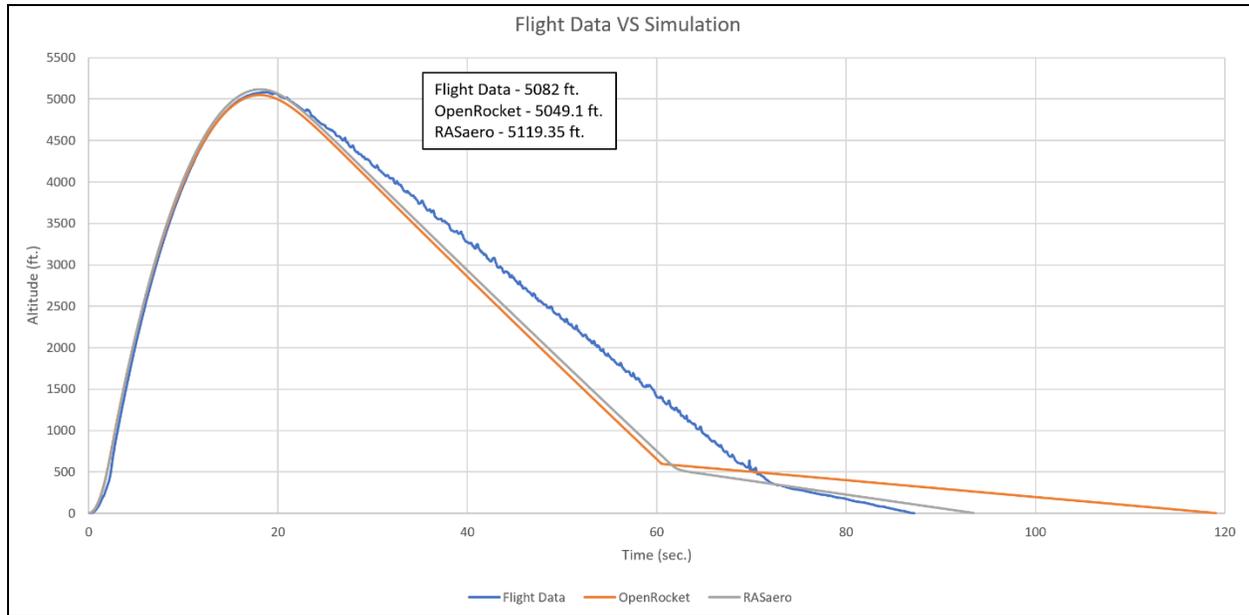
Figure 1: Flight Data Comparison

For the flight analysis, a predicted coefficient of drag of 0.33 was used. This value seems to be spot on, as the simulation results align very closely with that of the actual flight data. The figure below shows a comparison of the flight simulations and the flight data. When compared to the OpenRocket simulation, the apogee was 32.9 feet low, which results in an error of 0.65%. When compared to the RASaero simulation, the apogee was approximately 37.35 ft. high, which results in an error percentage of roughly 0.75%. With such low error percentage, it can be said that the simulations are great estimations for the predicted apogee results.

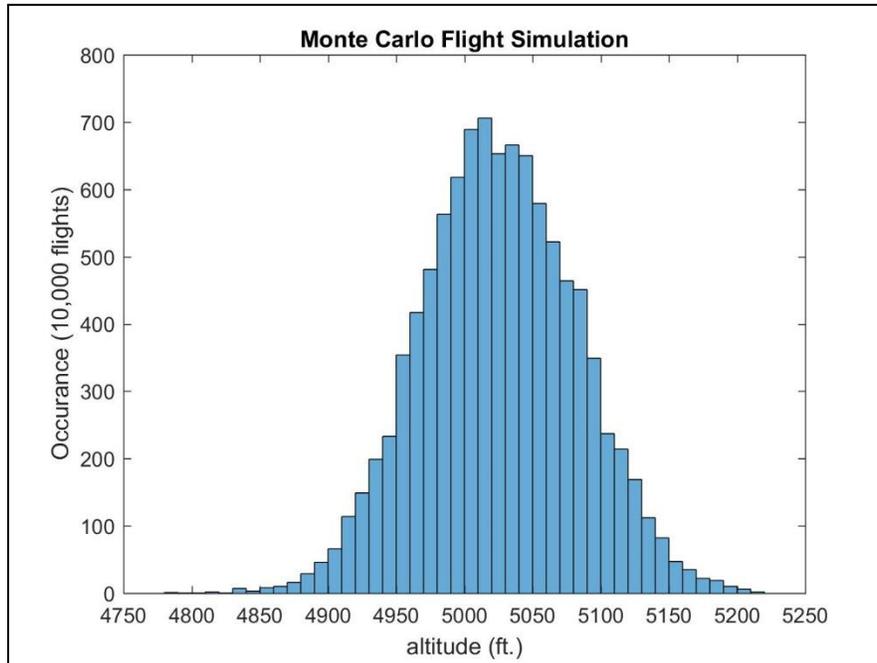
Figure 2: Monte Carlo Simulation Results

The flight's apogee can also be compared to the in-house Monte Carlo which was designed to help better predicted an apogee value based on uncertainties. Through flight testing, calculations, and measurements, the uncertainty value input into the Monte Carlo were about to be cut down to very small percentages, with the highly level uncertainty being in the propellant mass section. After running the Monte Carlo simulation for 10000 flights, a mean apogee value was output of 5025.6 ft. This value is slightly lower than what was achieved. This error percentage can be found to be roughly 1.11%. The error can be a result of a high level of uncertainty in the propellant mass weight. The manufacturer claims a rough estimate of $\pm 6\%$ on every motor produced. This is what is believed to be the highest source of error within the Monte Carlo calculation. The results of the Monte Carlo simulations are shown in Figure 2.

Overall, the simulations that were conducted to help better estimate the apogee of the vehicle can be said to be well within the acceptable region for a given flight. This outcome can be accepted due to the low error percentages achieved when running the various simulation method. The low error percentages can be achieved by having a great level of detail which was achieved when putting the various inputs into any given simulation.

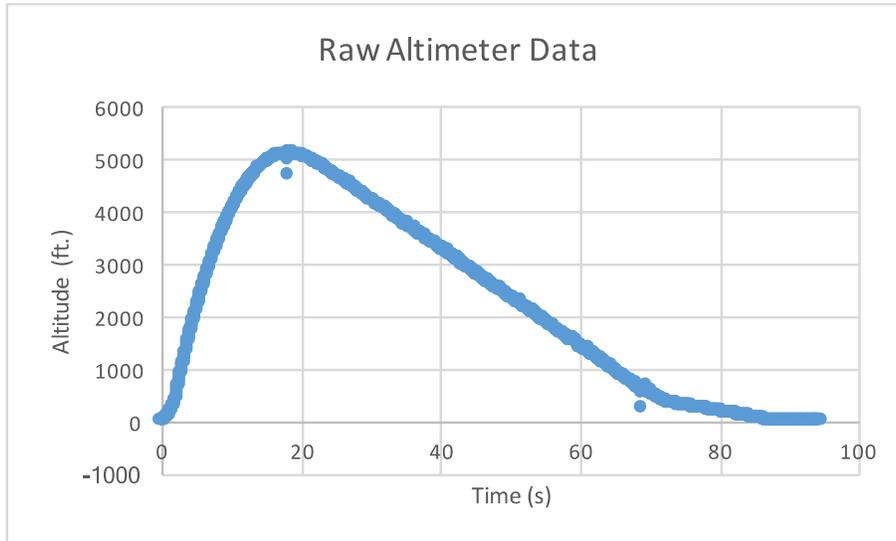
Figure 3: Stratologger CF Flight Data

The recovery system altimeters (PerfectFlite Stratologger CF's) properly commanded parachute deployment charges at their assigned altitudes. Figure 3 shows the data curve from the primary altimeter (which was the officially scored altimeter). For the primary altimeter, the drogue charge was set at a zero apogee delay and the main was programmed to deploy at 600 ft. AGL. The backup altimeter commanded the secondary drogue charge at a one second delay after apogee, and the second main charge was commanded at 550 ft. AGL. Through pre-launch black powder testing, the team determined the drogue parachute charge should be 2.25g with a backup of 2.75g and the main should be 3g with a backup charge of 3.5g. It appeared that primary charges were successfully ignited and separated the rocket in both cases.

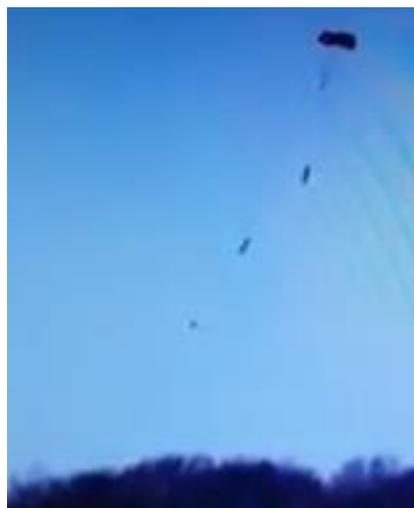
Figure 4: Descent Under Main

The drogue parachute successfully deployed after the first charge event, completely unfurled, and controlled the rocket descent in a linear fashion. The velocity under the drogue parachute was about 89.16 ft./s which is very similar to previous full scale flights. Similarly, the main parachute deployed after its first charge event and slowed the rocket to a descent velocity of 23.45 ft./s which is slightly higher than predicted, resulting in a landing kinetic energy of 154.21 ft-lbf (for the heaviest section). It is unclear exactly what caused this higher descent speed, though it is theorized that the main parachute did not completely unfurl during its descent. Figure 4 shows the rocket during its descent under main.

The rocket landing spot was within the predicted radius 2153.61 feet under 10 mph winds. Analysis of altimeter data showed that the descend rate under the main parachute was abnormally high compared to the two test flights. Upon inspection of photographs and videos of the flight, it was discovered the main parachute did not open to its full diameter (only 80% or 90% of its full size) and continued to do so till touchdown. The cause of problem is yet to be determined since the procedure for recovery preparation was followed properly at every launch attempts.

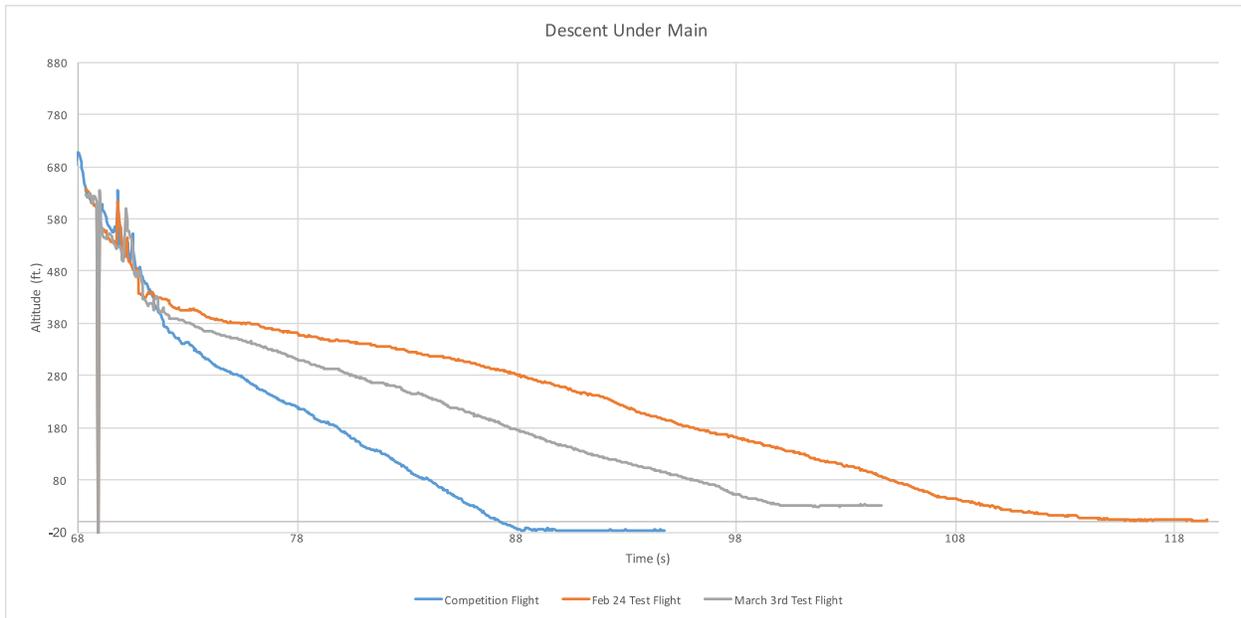
Figure 5: Comparison of Descent Under Main Parachute

A comparison was done for all three full-scale flights including the competition flight to show the time it typically takes the main parachute to fully deploy and to also show the difference in descent velocities experienced. The results are summarized in Figure 5. It can be seen that the main parachute took just a fraction of time longer to inflate but the descent speed is drastically different.

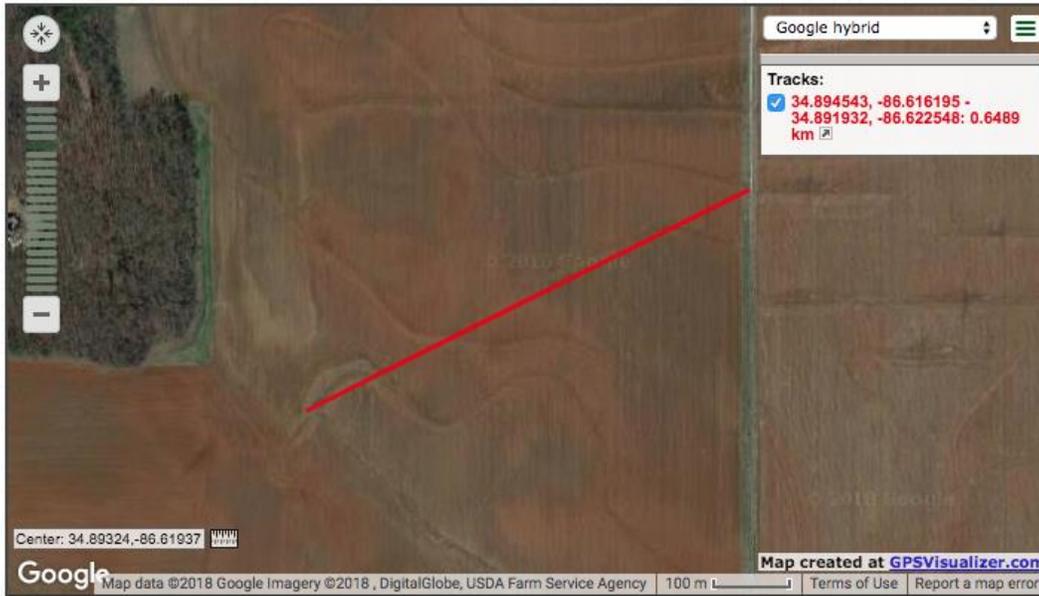
Figure 6: Drift Diagram

To determine the total drift distance from the launch pad, the tracker coordinates for the launch and landing were input into a mapping software to measure the distance. Figure 6 below shows the rocket drifted a total of 2127.84 ft. from the launch rail, which is within the 2500 ft. requirement. This landing zone was determined by the team however, based on where they found the rocket. It appears from the altimeter data that the rocket landed and then was dragged several feet by the main parachute before the team reached it. The last packet from the GPS tracker indicates that it was only 434 ft. from the launch rail, but it is suspected that there was an issue with the tracker that caused it to lose its GPS lock.

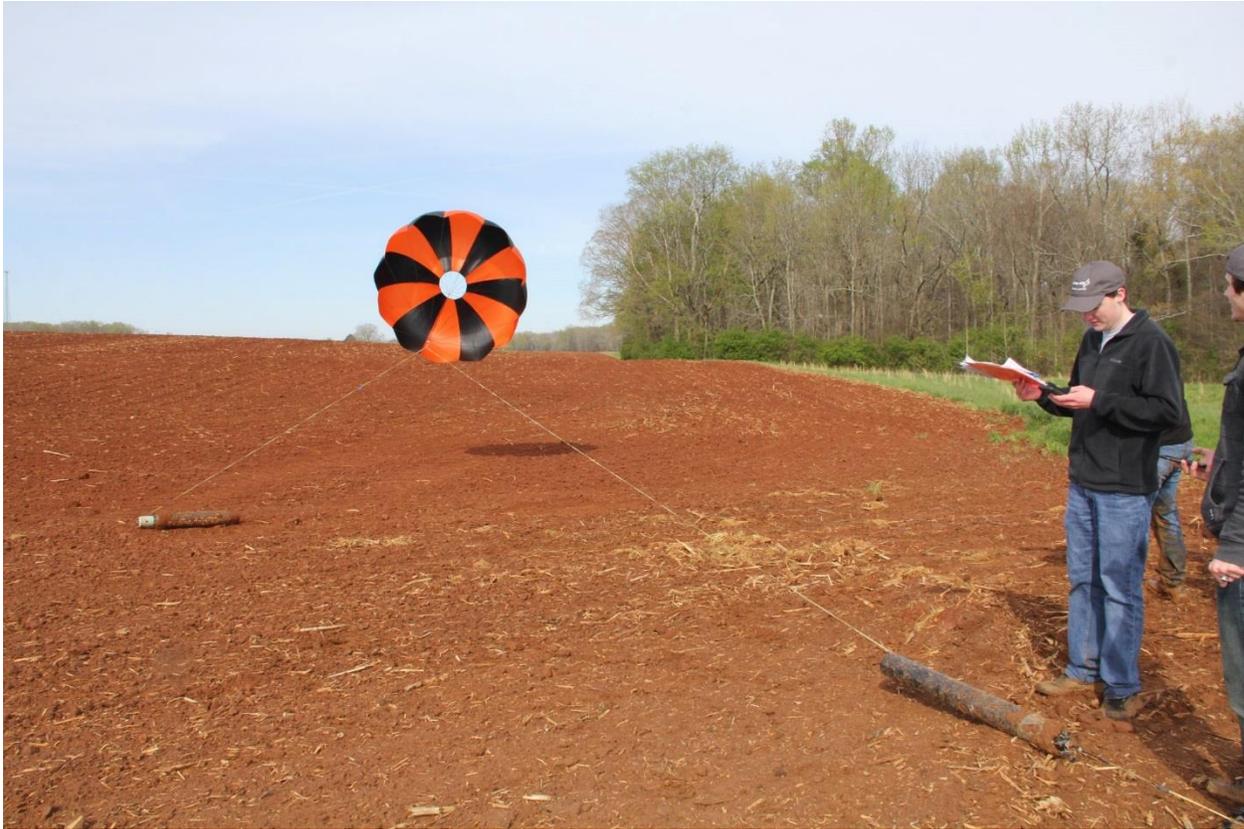
Figure 7. Rocket after Landing

The flight started off mostly vertical. There was a noticeable amount of weather cocking shown pictures and videos taken. This was expected due to the heavy mass in the front. The rocket had also exhibited the same behavior in previous flights. However, the issue corrected itself and the vehicle continued to rise in altitude. The rocket reached an apogee of 5080 ft. (according to the official scoring altimeter). The vehicle then deployed the drogue and continue to descend downwards. At the altitude of 600 ft., the main parachute deployed. The vehicle and payload touched down approximately 0.4 mi. away from the launch pad. When the team arrived at the landing site, it was found that the parachute has dragged the rocket roughly 50 feet from its original landing spot. The content of the rockets was covered in wet mud but was intact.

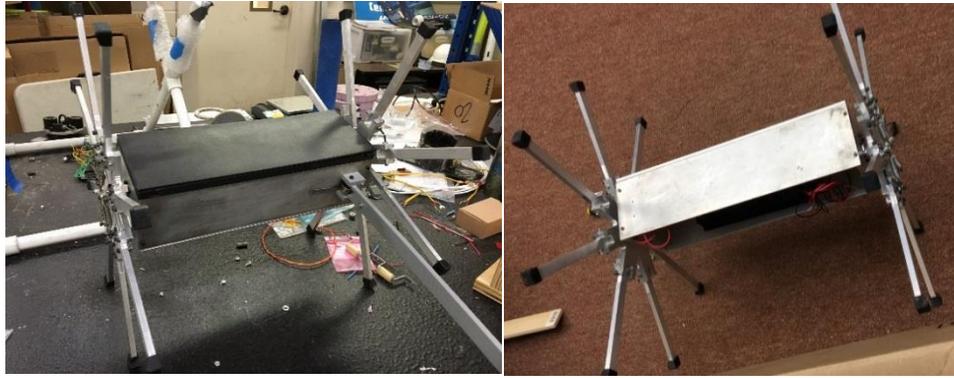
Figure 8. Rover Assembly

The rover chassis was completed after the FRR. The chassis housed all the electronics which were contained in an electronics tray. It was made of five assembled plates of aluminum to avoid any damage to electronics during flight and deployment.

The tray was originally printed using a Fortus in the UAH machine shop, but it was reprinted on the 3D printer in the PRC after discovering the electronics did not align with the standoffs. This printer was smaller, so the tray was redesigned to be a bit smaller so that the printer could make it. It was also decided that the tray should also have UAH and labels for the electronics added to it in the actual print. Despite leaving plenty of room for the electronics, wiring made everything fit very tight and given more time, more wire management would have been planned in the design.

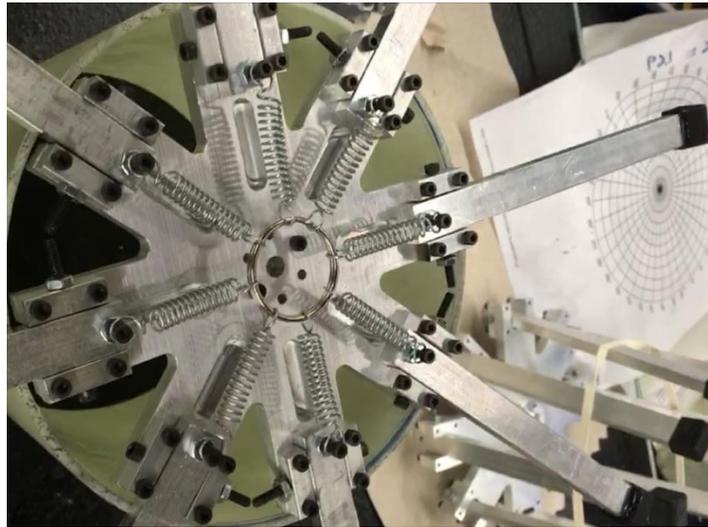
Figure 9. Wheel Assembly

The wheels were designed as three pieces as initially planned in the FRR. The spokes and hinges were already made at FRR, but the wheel hub was not made yet. The spokes and hinges were cut to length on a manual mill. The hole originally designed for the spring on the spoke was drilled using a regular drill press in the PRC, but the hole designed to assemble to the wheel hub needed to be more precise, so it was drilled using the manual mill. The holes on the wheel hinges were also made using the manual mill.

The wheel hub was made using the CNC. After it was made, there were some complications with assembling the springs as initially planned using fishing line. It was decided that the springs would be attached in the following configuration: one end would be attached to a key ring in the center of the wheel hub, while the other end was attached to a 4-40 bolt which protruded from the base of the spoke. It was also discovered that the springs deformed a lot more than expected so if given more time, a redesign would have occurred to cause less strain on the springs.
