Flight Readiness Review Addendum
2019 NASA University Student Launch Initiative
25 March 2019

Propulsion Research Center
301 Sparkman Dr. NW, Huntsville, Al
256.824.7209

Charger Rocket Works

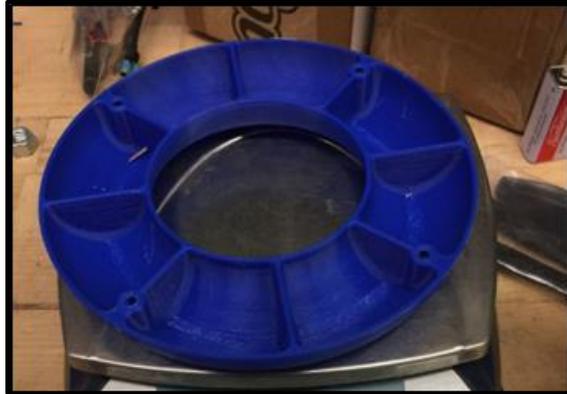
Figure 2: Vehicle Ballast Ring

A ballast mount was also added to the vehicle, as shown in Figure 2. The ballast mount was 3D printed in a half-toroidal shape with cutouts for ballast placement. Ballast was added by epoxying stainless steel BB pellets into pockets in the ring. This component was mounted via four #4-40 bolts to the top of the removable fin can system using brass heat-set inserts. This methodology is identical to how the motor retention ring is mounted to the bottom of the fin can. This mount will not be flown during the competition flight, as the payload demonstration flight showed that no ballast is required.

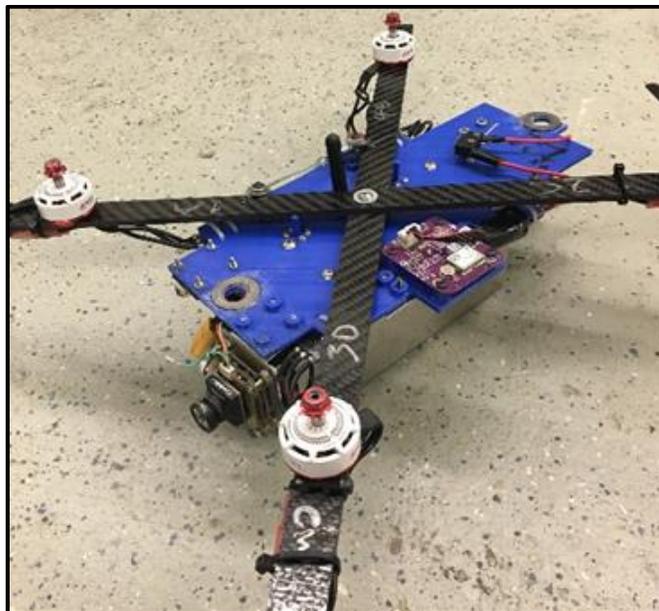
Figure 3: UAV with Changes Since FRR

Initial versions of the UAV arm retention pins often sheared when in use. This was corrected by reprinting the pins with the direction of loading normal to the build plane. This significantly increases the force required to shear the pins.

A sheet metal bracket for the beacon retention system was constructed and mounted to the UAV. Lastly, the holes on either end of the UAV that allowed it to be mounted onto the sheath were reinforced with large washers that were epoxied to the surface of the PLA. This provides support to the upper mounting plate of the UAV during the black powder ejection and is visible in Figure 3.

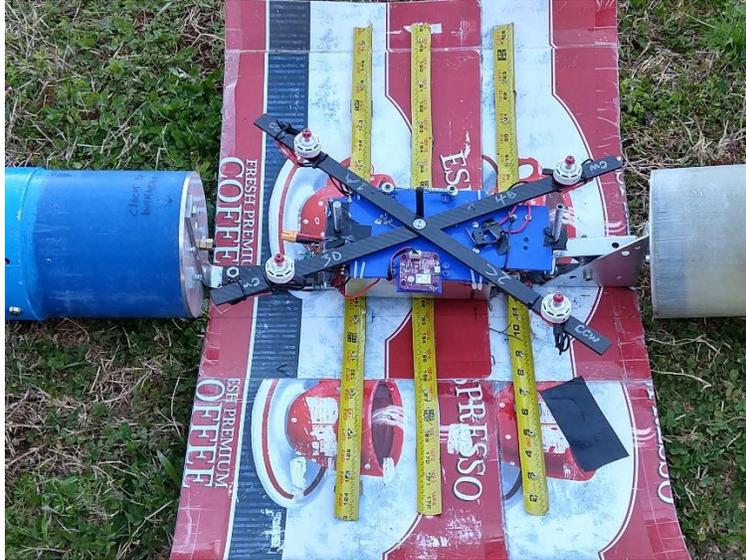
Figure 5: Deployed Payload After Black Powder Test

Ground black powder testing was conducted with the completed assembly, shear pins, and UAV. The system was qualified for flight after 2 successful, consecutive deployments with a UAV mass simulator, and an additional successful deployment with the UAV. Figure 5 shows the deployed payload after the final ejection test.

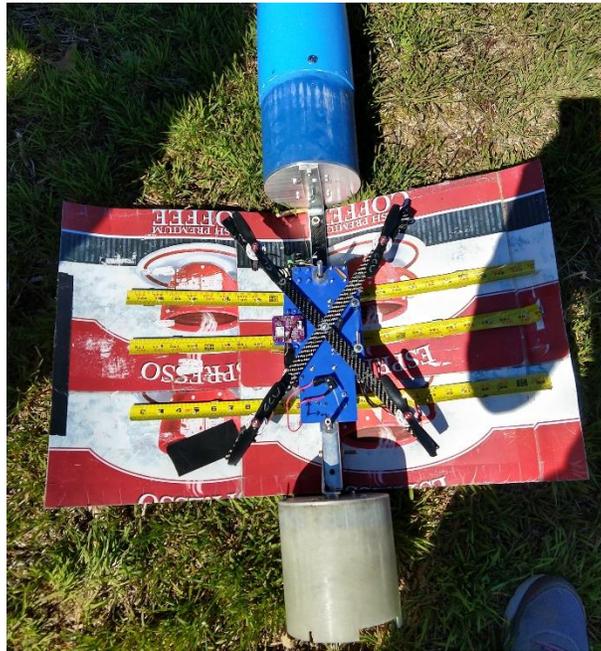
Figure 6: Payload After Deployment

After commanding deployment, the solenoid retracted and the primary black powder charge was ignited, pushing the payload out of the rocket body tube. The sheath reoriented the UAV to an upright position as intended, placing it in the position shown in Figure 6.

The orientation system functioned as expected. The deployment sheath unfurled so that the UAV was right side up. The UAV arms unfolded and released the flight computer power switch.

Inspection of the UAV after deployment showed that although the switch was released the UAV was still powered off. This was found to be due to a loose electrical connector on the flight computer power switch. Additionally, although the arms were unfolded, only one of the two arms was locked in position. This was because of inadequate tension on the arm extension spring. Finally, the solenoid mount, a U-shaped bracket made from aluminum, was slightly bent, allowing the solenoid to move away from the beacon. This is believed to be due to the acceleration during deployment black powder ejection.
