Post Launch Assessment Review
2019 NASA University Student Launch Initiative
29 April 2019

1 PLAR Summary

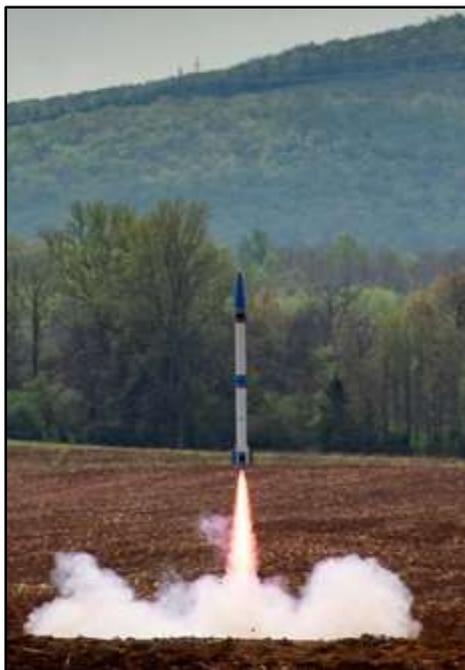
Figure 1: ShredIt 40,00 Test Flight

The University of Alabama in Huntsville's (UAH) Charger Rocket Works (CRW) team was proud to be a part of this year's Student Launch Initiative competition. The team successfully designed, built, tested and flew a 6-inch diameter launch vehicle spanning 124 inches in length from the tip of the nose cone to the base of the tail cone. This year's payload selection was the UAV and rover combination. The team's designed a UAV to fly a beacon to a future excursion area. The launch vehicle, *ShredIt 40,00*, flew on an Aerotech L1420 motor and reached an altitude of 4,600 feet. *ShredIt 40,00* can be seen below in Figure 1 during launch.

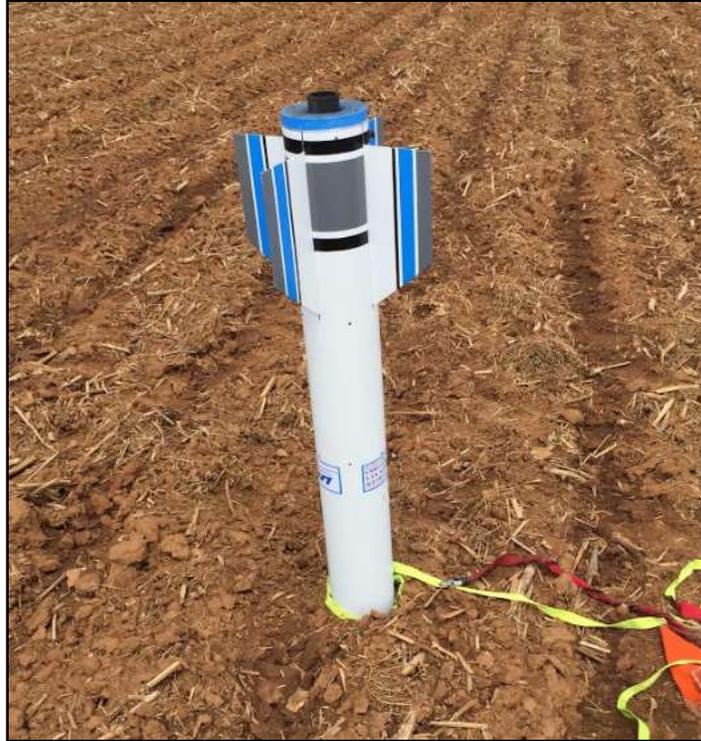
Figure 5: Lower Airframe After Landing

Despite the vehicle landing at high speeds, the airframes were intact upon retrieval. The lower airframe, shown in Figure 5, landed vertically with the forward end embedded in the soil of the launch field. The vehicle was able to meet the total drift requirement as the GPS tracker recorded a total drift distance of 1105 feet from the launch pad. Likewise, the vehicle descended in 58.35 seconds and was able to meet the 90 second descent requirement. Due to the vehicle landing at drogue speeds, the vehicle landed with a kinetic energy of 1842.4 lbf-ft much larger than the kinetic energy requirement of less than 75 ft-lbf. Plots of the launch day data recorded by the Raven3 altimeter in the nose cone is shown in Appendix A.

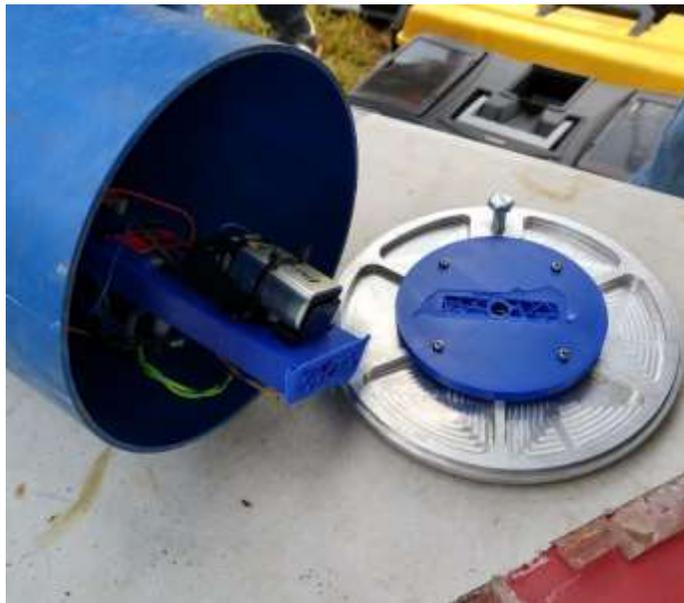
Figure 6: Nose cone avionics mount post-landing

The nose cone avionics mount failed to withstand the force during landing. As a result, the 3D printed mount sheared near the bottom where there was a sharp angle. Despite the mount shearing, the electronics were undamaged and were able to record data throughout the entire flight. This is due to the fact that the mount is redundantly retained by the threaded rod running through

the nose cone. Future designs will require more thorough loading analysis to withstand harsh landings such as this.

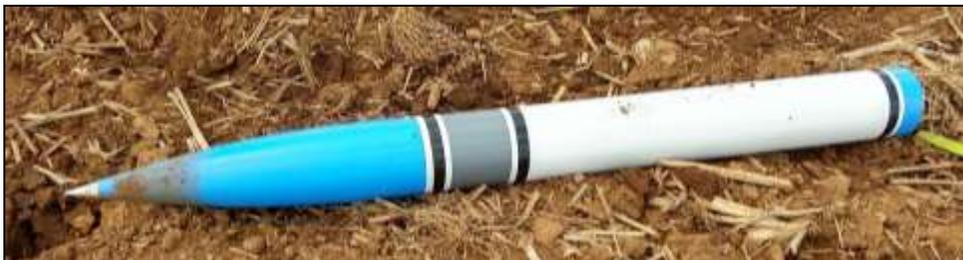
Figure 8: Upper Airframe Prior to Payload Deployment

A walk-around and assessment of the vehicle state was conducted. The deployment system was verified to be powered on and emitting a 1 Hz tone, indicating it was in the disarmed state. The upper airframe position upon landing is shown in Figure 8.

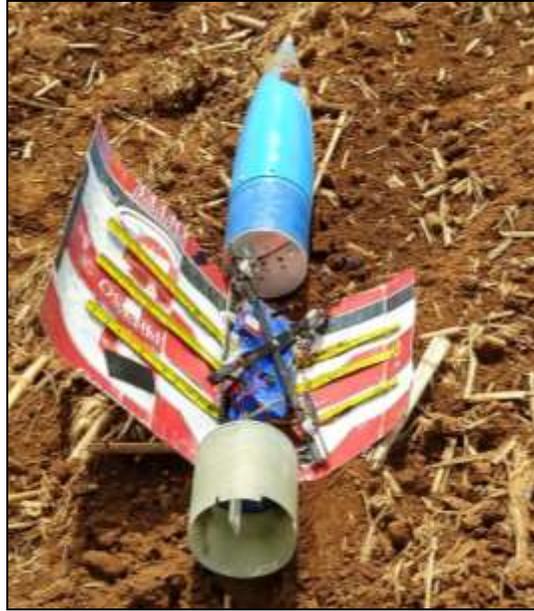
Figure 9: Payload Orientation after Ejection

After clearing the area of personnel, payload deployment was conducted. Initial attempts to remotely arm the deployment controller were unsuccessful; after consultation with the RDO representative present, the test conductor approached the upper airframe power cycled the deployment controller. Upon power cycling, the deployment controller responded to arming commands as expected and ejected the payload. The payload position after ejection is shown in Figure 9; note that it stopped in furrow.

The launch day results of the UAV and deployment system carried several important lessons for design and implementation of future missions. Future deployment systems should consider to a more in-depth extent the terrain on which the UAV will be deploying. The mechanical operation of the deployment system proved to have few points of failure; however, a more robust and versatile system should be designed to better handle rocket launch and landing forces as well as more rugged deployment terrain. Payload integration with the rocket should be considered better in the future. The payload team experienced many difficulties with loading the payload into the rocket body tube. Eventually, the load time was brought down for roughly two hours to approximately twenty minutes, but this should be design better in the future. A more aggressive schedule might produce test results and data more quickly, which could then be used to improve the payload at a good amount of time before competition day. While the payloads failure on launch day was not related to this, it would prove beneficial to stay on a tighter schedule for testing and troubleshooting.

The team developed a unique orientation system, utilizing only simple mechanical systems with few points of failure. However, systems of this type are only effective on relatively flat even surfaces, unlike those encountered at the launch field. The flight proves that this system should not be utilized in most situations, aside from applications where the landing area is well-surveyed and even.

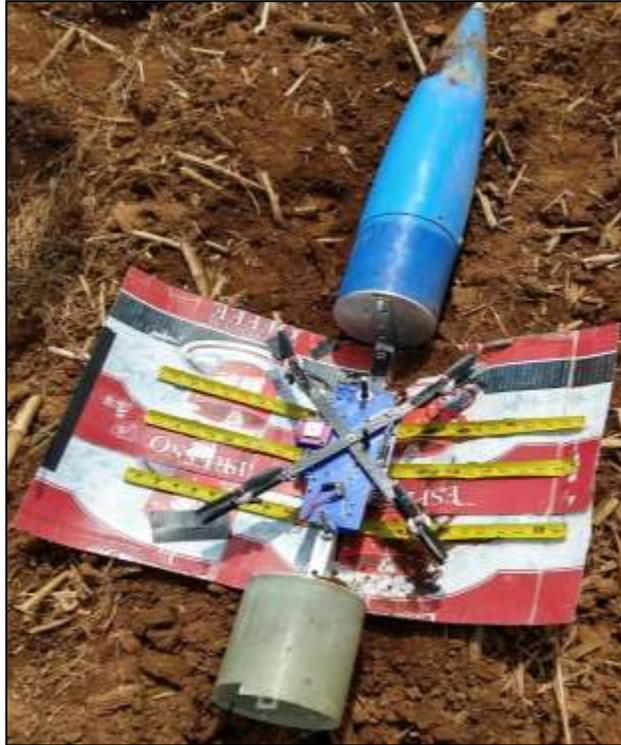
Figure 10: UAV Prior to Lift Off

After ejection, the backup charge was fired to remove all energetics from the vehicle, rendering it safe for the team to approach. The team concluded that the UAV would not be able to lift off from the as-deployed position. The arms were not fully extended or locked in place and the UAV was at a significant angle, likely preventing it from lifting off of the posts on the orientation sheath. The team elected to reorient the UAV and deployment sheath before takeoff, rather than risk damage to the UAV by attempting to take off at an angle. Figure 10 shows the UAV before takeoff; note that the UAV airframe has fractured around the aft retention post.

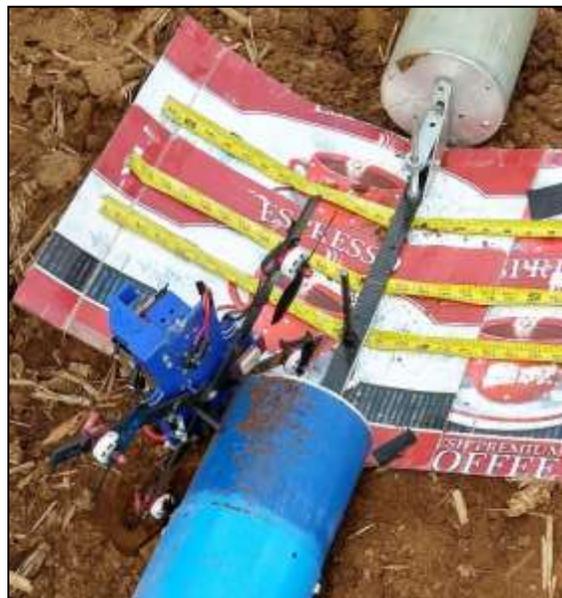
Figure 11: UAV After Takeoff Attempt

The UAV connected successfully to the telemetry and control ground station, but the video stream could not be acquired. The team elected to attempt the mission without a live video stream. Upon takeoff, the UAV pitched forwards and impacted the ground, breaking both front rotors. Figure 11 shows the state of the UAV after the takeoff attempt.
